New Hampshire Volunteer Lake Assessment Program

2003 Biennial Report for Shellcamp Pond Gilmanton

Shellcamp Pond, Gilmanton

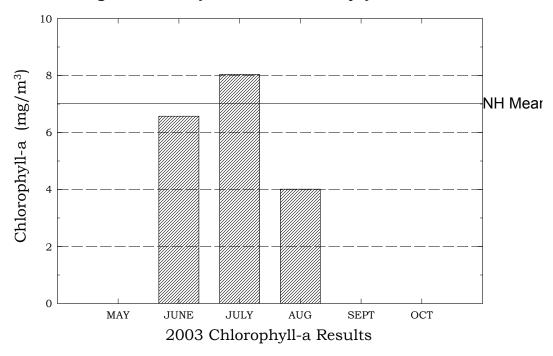
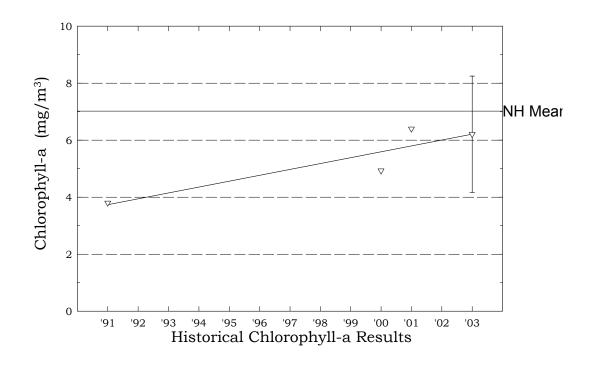
Figure 1. Monthly and Historical Chlorophyll-a Results

Figure 1 and Table 1: The graphs in Figure 1 (Appendix A) show the historical and current year chlorophyll-a concentration in the water column. Table 1 (Appendix B) lists the maximum, minimum, and mean concentration for each sampling season that the lake/pond has been monitored through the program.

The current year data (the top graph) show that the chlorophyll-a concentration *increased* from June to July, and then *decreased greatly* from July to August. The chlorophyll-a concentration in July (8.04 mg/m³) was *greater than* the state mean.

The historical data (the bottom graph) show that the 2003 chlorophyll-a mean is **slightly less than** the state mean.

Overall, visual inspection of the historical data trend line (the bottom graph) shows *an increasing* in-lake chlorophyll-a trend, meaning that the concentration has *worsened* since monitoring initially began in 1991. However, please note that the pond was not sampled from 1992 to 2000, and was also not sampled in 2002. In 1991, the chlorophyll concentration was 4 mg/m³. During the 2000, 2001, and 2003 sampling seasons, the chlorophyll concentration ranged between 5 and 8 mg/m³. After 10 consecutive years of sample collection, we will be able to conduct a statistical analysis of the historic data to objectively determine if there has been a significant change in the annual mean chlorophyll-a concentration since monitoring began.

While algae are naturally present in all lakes/ponds, an excessive or increasing amount of any type is not welcomed. In freshwater lakes/ponds, phosphorus is the nutrient that algae depend upon for growth. Algal concentrations may increase with an increase in nonpoint sources of phosphorus loading from the watershed, or inlake sources of phosphorus loading (such as phosphorus releases from the sediments). Therefore, it is extremely important for volunteer monitors to continually educate residents about how activities within the watershed can affect phosphorus loading and lake/pond quality.

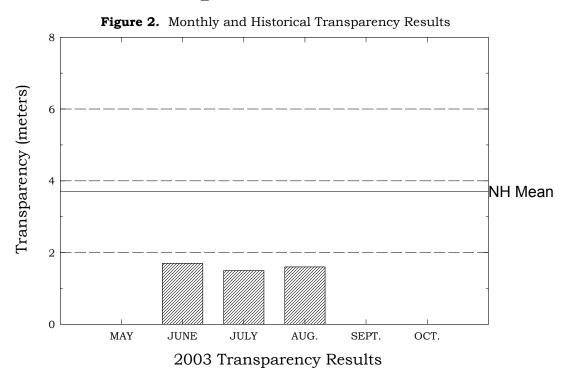
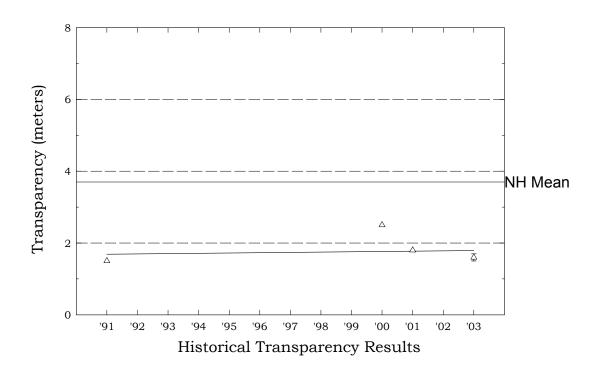
Figure 2 and Table 3: The graphs in Figure 2 (Appendix A) show historical and current year data for lake/pond transparency. Table 3 (Appendix B) lists the maximum, minimum and mean transparency data for each sampling season that the lake/pond has been monitored through the program.

The current year data (the top graph) show that the in-lake transparency *remained relatively stable* from June to August.

Overall, visual inspection of the historical data trend line (the bottom graph) shows *a relatively stable* trend for in-lake transparency. Specifically, since monitoring originally began in 1991, the transparency has ranged between approximately 1.5 and 2.5 meters. Again, please remember that this trend is based upon four nonconsecutive sampling seasons. As discussed previously, after 10 consecutive years of sample collection, we will be able to conduct a statistical analysis of the historic data to objectively determine if there has been a significant change in the annual mean transparency since monitoring began.

Typically, high intensity rainfall causes erosion of sediments into lakes/ponds and streams, thus decreasing clarity. Efforts should continually be made to stabilize stream banks, lake/pond shorelines, disturbed soils within the watershed, and especially dirt roads located immediately adjacent to the edge of tributaries and the lake/pond. Guides to Best Management Practices designed to reduce, and possibly even eliminate, nonpoint source pollutants, such as sediment loading, are available from DES upon request.

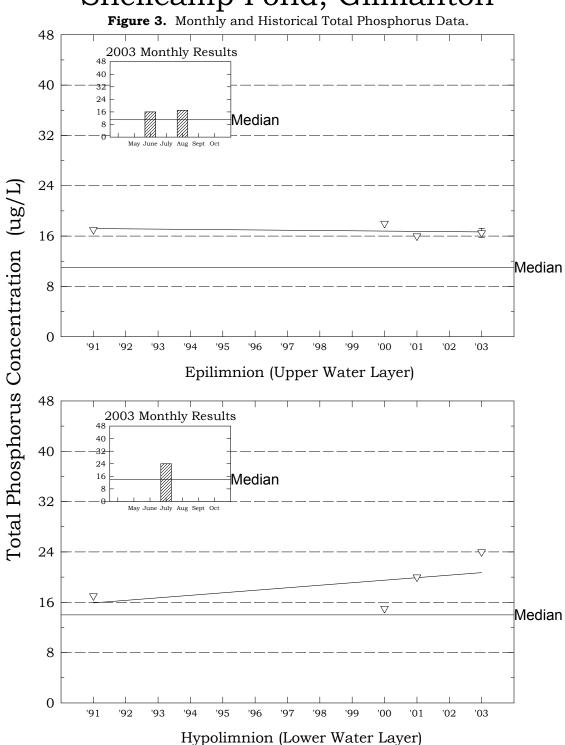
Figure 3 and Table 8: The graphs in Figure 3 (Appendix A) show the amounts of phosphorus in the epilimnion (the upper layer) and the hypolimnion (the lower layer); the inset graphs show current year data. Table 8 (Appendix B) lists the annual maximum, minimum, and median concentration for each deep spot layer and each tributary since the lake/pond has joined the program.

The current year data for the epilimnion (the top inset graph) show that the phosphorus concentration *increased very slightly* from June to August. (Please note that a phosphorus sample was not collected from the epilimnion on the July sampling event.) The phosphorus concentration in June and August was *greater than* the state median.

The current year data for the hypolimnion (the bottom inset graph) show that the phosphorus concentration in July was *greater than* the state median. (Please note that a phosphorus sample was not collected from the hypolimnion on the June or August sampling events.)

Overall, visual inspection of the historical data trend line for the epilimnion shows a *relatively stable* phosphorus trend which is slightly *greater than* the state median. Specifically, the phosphorus concentration in the epilimnion has ranged between approximately 16 and 18 ug/L since monitoring originally began in 1991.

Overall, visual inspection of the historical data trend line for the hypolimnion shows a *slightly increasing* phosphorus trend, which means that the concentration has *slightly worsened* since monitoring began.

We understand that your monitoring group has chosen to conduct phosphorus sampling on a limited basis each sampling season. Therefore, we recommend that your group sample the epilimnion (1 meter) consistently on each sampling event.

One of the most important approaches to reducing phosphorus loading to a waterbody is to continually educate watershed residents about its sources and how excessive amounts can adversely impact the ecology and value of lakes and ponds. Phosphorus sources within a lake or pond's watershed typically include septic systems, animal waste, lawn fertilizer, road and construction erosion, and natural wetlands.
